HYDRO GROUP AIR STRIPPING INSPECTION REPORTS

INSPECTION REPORT #2922-92-1

SITE: City of Norwalk, CT
FACILITY: Layne-Dearing Well Field Tower
DATE OF INSPECTION: October 14, 1992
INSPECTED BY: Michelle D. Saczynski & Kimberlie Staheli
DATE OF REPORT: December 9, 1992

AIR STRIPPING SYSTEM INSPECTION REPORT
REPORT # 3105-95-1

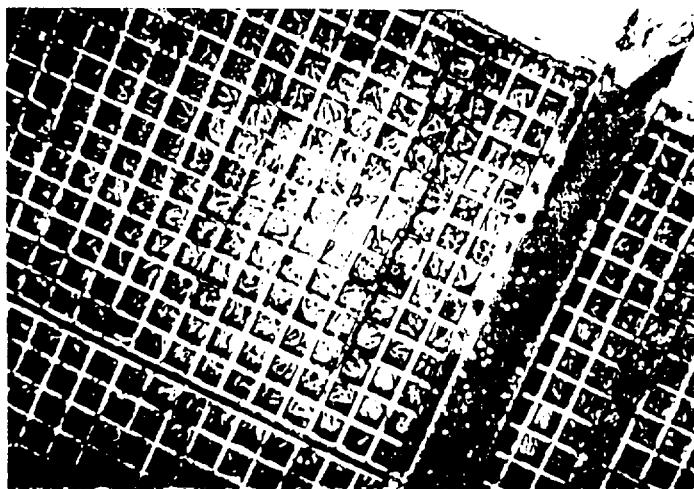
<- Photo 2

Since there was no packing retaining screen over the manway, the cover was only cracked open. From that view the packing appeared to be slightly stained with manganese oxide.

1. Distributor Tray and Top of Packed Bed - Note the dark manganese oxide stains on the tray and packing surfaces, and the light colored pit formations on the tray.
2. Bottom of Packed Bed - Note the dark colored manganese oxide stains on the support plate and packing.
4. Tower Sump - Note the light colored pit formations on the sump floor.

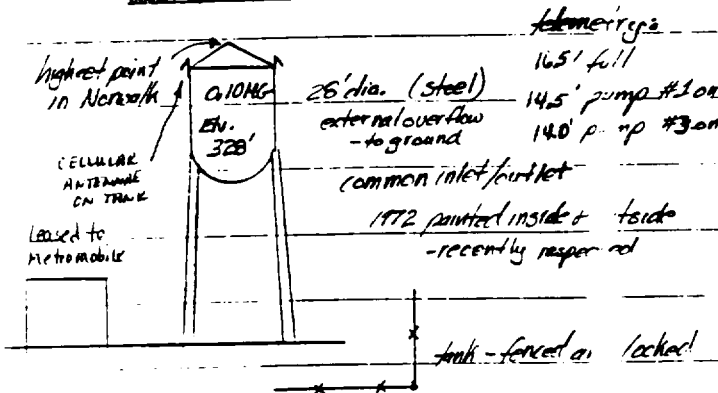
West Rock Elevated Tank:

20. The West Rocks elevated tank and the Bayne Street standpipe showed evidence of some rusting on the exterior surface. The Filbert Street tank paint was peeling and mildew/dirt was evident on the tank exterior surface. These tanks should be inspected to determine the integrity of the tank materials and repaired as necessary.

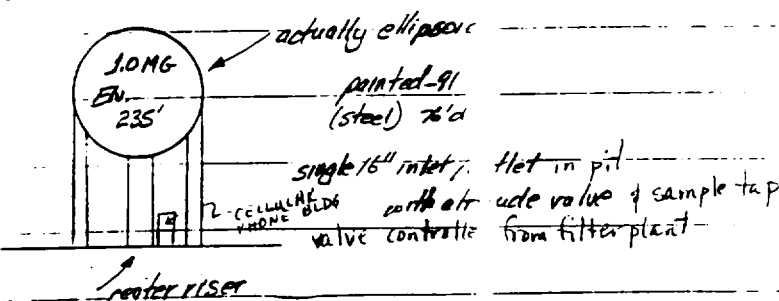
Elbert Street Tank (Water Ave):

21. One riser base of the Filbert Street tank was cracked at the time of the inspection. NFTD must inspect the base to determine the integrity of the support and repair as necessary.
